**Flood Control Project Maintenance
Levee Inspections**
LMA District Cover Sheet
Spring 2017 Levee Inspection Results

Levee District No. 0002 (Glenn County)

Spring 2017 Levee Inspection Results

| Waterway | | | Bank | Unit Miles |
|---|---|---|---|---|
| Unit No. 01 Glenn County Sacramento River | | | Right | 4.90 |

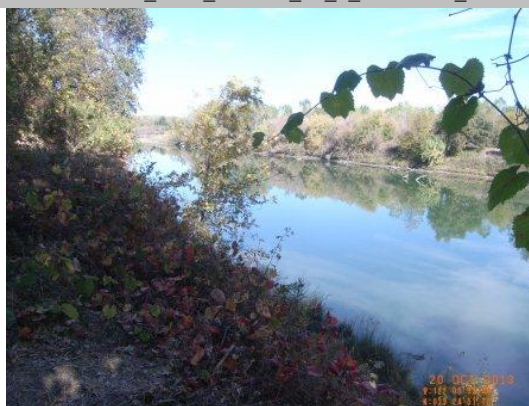
Photo 1 of 2 : SP_2017_LD0002_28_6_20170315_00003.jpg

| 2009 - Very slow retreat, hard toe, encroaching into the levee projection. 2010 - Slowly eroding. 2011 - Site extended downstream. 2015: Last observed in 2013. [2015 Site ID: SAC_164-7_R] | | | | | |

USACE 2013 Photo #1

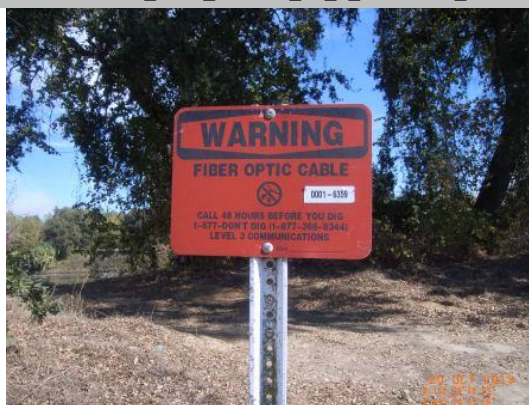
Photo 2 of 2 : SP_2017_LD0002_28_6_20170315_00004.jpg

USACE 2013 Photo #2

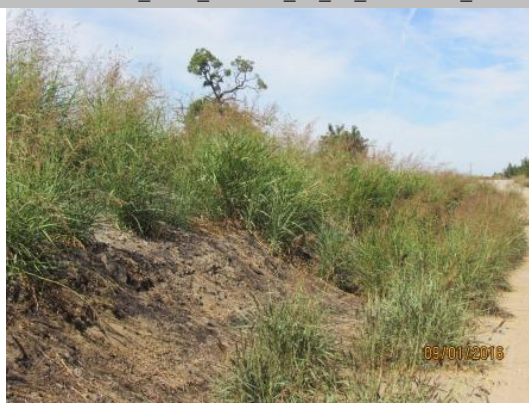
Photo 1 of 1 : SP_2017_LD0002_28_32_20170315_00015.jpg

View of the waterside vegetation looking upstream.

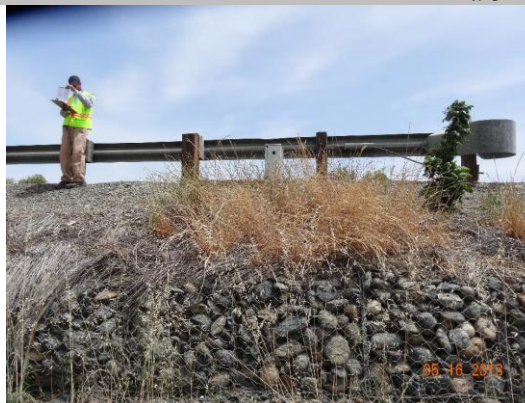
Photo 1 of 3 : UCIP_SP_2017_42083_72882.jpg

View of landward slope.

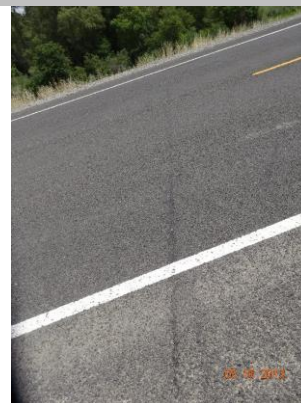
Photo 2 of 3 : UCIP_SP_2017_42083_72881.jpg

View of levee crown at crossing.

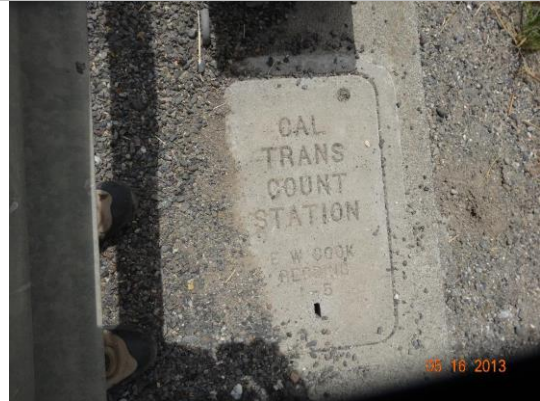
Photo 3 of 3 : UCIP_SP_2017_42083_72880.jpg

Service box located on landward shoulder.

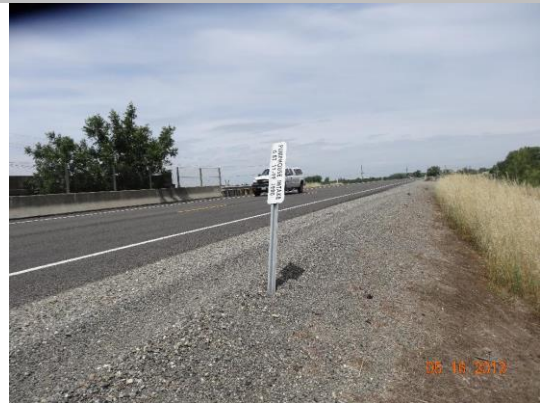
Photo 1 of 3 : UCIP_SP_2017_38165_69467.jpg

| FS_ID:38165 DS_ID:21185 EP_NO: 2356 Repair Type: Non-Urgent Crossing Status: Found UCIP Comments: Three pipes found in the pump house on landward side. Pump house appears to be no longer in use. Unable to locate pipes on waterward side. Will need to contact owner to determine status. Owner will need to coordinate with CVFPB regarding proper removal per Title 23 requirements. FIELD_STRUCT_DESC: [Princeton-Cordora-Glenn Irrigation District: Schaad Pumping Plant] 1 of 3: 28-inch steel pipe sleeved through 30-inch steel pipe through the levee, 20.0 feet below the crown. Annular gap is grouted. Flap gate on landside (LS) end. Pump in pump house on LS slope. Rock revetment around outlet on waterside (WS) slope. (Permit No. 2356-1956, Princeton-Cordora-Glenn Irrigation District) FS Date: 5/16/2013 | | | | | |

View of levee crown at crossing.

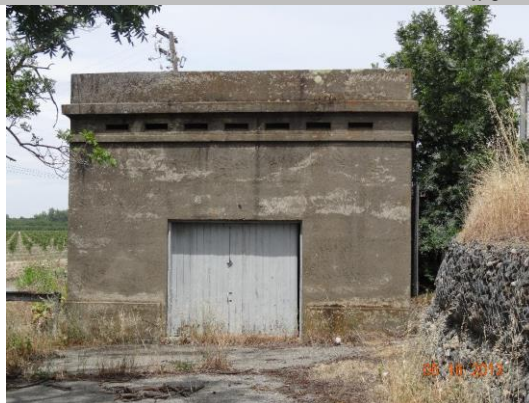
Photo 2 of 3 : UCIP_SP_2017_38165_69469.jpg

UCIP Comments: Three pipes found in the pump house on landward side. Pump house appears to be no longer in use. Unable to locate pipes on waterward side. Will need to contact owner to determine status. Owner will need to coordinate with CVFPB regarding proper removal per Title 23 requirements.

View of Princeton-Cordora-Glenn Irrigation District--Schaad Pumping Plant.

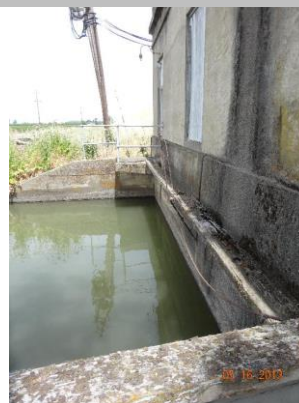
Photo 3 of 3 : UCIP_SP_2017_38165_69463.jpg

View of landward side--outlet.

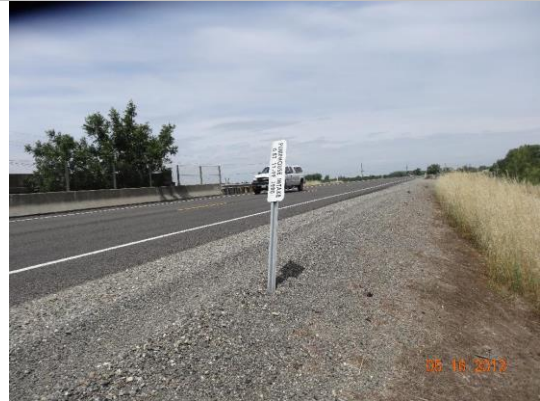
Photo 1 of 3 : UCIP_SP_2017_38166_69475.jpg

FS_ID:38166
DS_ID:21184
EP_NO: N/A
Repair Type: Non-Urgent
Crossing Status: Found
UCIP Comments: Three pipes found in the pump house on landward side. Pump house appears to be no longer in use. Unable to locate pipes on waterward side. Will need to contact owner to determine status. Owner will need to coordinate with CVFPB regarding proper removal per Title 23 requirements.
FIELD_STRUCT_DESC: [Princeton-Cordora-Glenn Irrigation District: Schaad Pumping Plant] 2 of 3: 34-inch steel pipe sleeved through 36-inch steel pipe through the levee, 20.0 feet below the crown. Annular gap is grouted. Flap gate on landside (LS) end. Pump in pump house on LS slope. Rock revetment around outlet on waterside (WS) slope. (USACE-1955). This entry matches the Drainage or Irrigation Structure referenced in O&M manual (Station 41+47). Pipes sleeved through pre-existing pipes installed under Permit No. 2356 (1956). (Permit No. 2356-1956, Princeton-Codora-Glenn Irrigation District)

View of levee crown at crossing.

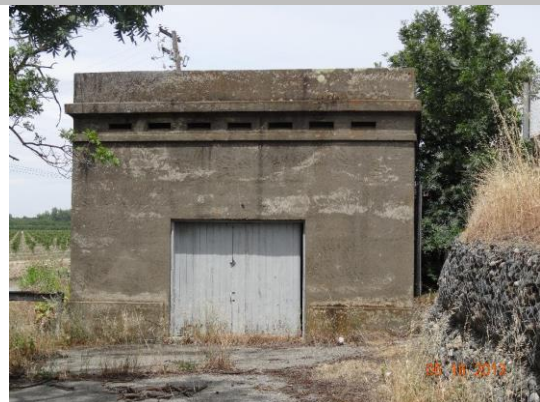
Photo 2 of 3 : UCIP_SP_2017_38166_69476.jpg

View of Princeton-Cordora-Glenn Irrigation District--Schaad Pumping Plant.

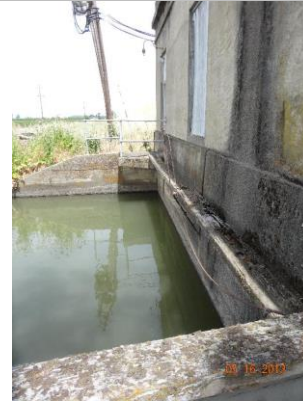
Photo 3 of 3 : UCIP_SP_2017_38166_69477.jpg

| FS_ID:38166 DS_ID:21184 EP_NO: N/A Repair Type: Non-Urgent Crossing Status: Found UCIP Comments: Three pipes found in the pump house on landward side. Pump house appears to be no longer in use. Unable to locate pipes on waterward side. Will need to contact owner to determine status. Owner will need to coordinate with CVFPB regarding proper removal per Title 23 requirements. FIELD_STRUCT_DESC: [Princeton-Cordora-Glenn Irrigation District: Schaad Pumping Plant] 2 of 3: 34-inch steel pipe sleeved through 36-inch steel pipe through the levee, 20.0 feet below the crown. Annular gap is grouted. Flap gate on landside (LS) end. Pump in pump house on LS slope. Rock revetment around outlet on waterside (WS) slope. (USACE-1955). This entry matches the Drainage or Irrigation Structure referenced in O&M manual (Station 41+47). Pipes sleeved through pre-existing pipes installed under Permit No. 2356 (1956). (Permit No. 2356-1956, Princeton-Codora-Glenn Irrigation District) FS Date: 5/16/2013 | | | | | | |

View of landward side--outlet.

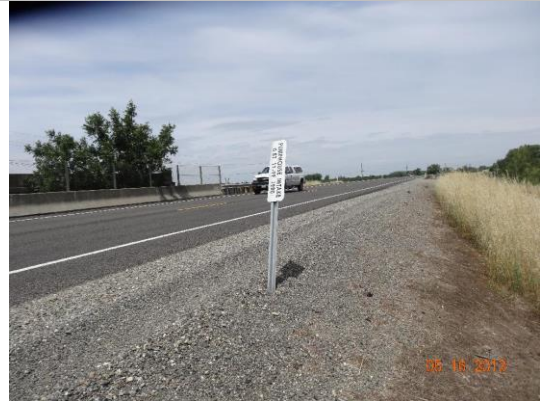
Photo 1 of 3 : UCIP_SP_2017_38167_69483.jpg

| FS_ID:38167 DS_ID:21171 EP_NO: N/A Repair Type: Non-Urgent Crossing Status: Found UCIP Comments: Three pipes found in the pump house on landward side. Pump house appears to be no longer in use. Unable to locate pipes on waterward side. Will need to contact owner to determine status. Owner will need to coordinate with CVFPB regarding proper removal per Title 23 requirements. FIELD_STRUCT_DESC: [Princeton-Cordora-Glenn Irrigation District: Schaad Pumping Plant] 3 of 3: 34-inch steel pipe sleeved through 36-inch steel pipe through the levee, 20.0 feet below the crown. Annular gap is grouted. Flap gate on landside (LS) end. Pump in pump house on LS slope. Rock revetment around outlet on waterside (WS) slope. (USACE-1955). This entry matches the Drainage or Irrigation Structure referenced in O&M manual (Station 41+47). Pipes sleeved through pre-existing pipes installed under Permit No. 2356 (1956). (Permit No. 2356-1956, Princeton-Codora-Glenn Irrigation District) FS Date: 5/16/2013 | | | | | |

View of levee crown with marker on waterward side.

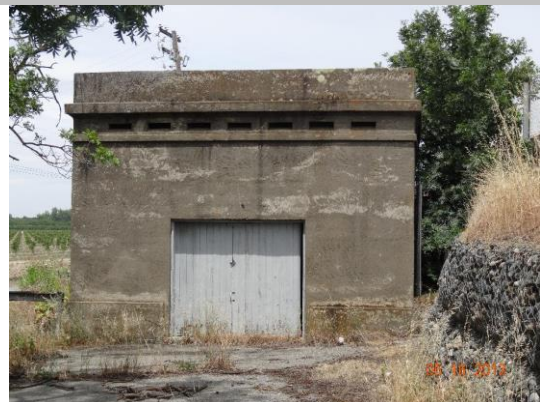
Photo 2 of 3 : UCIP_SP_2017_38167_69484.jpg

View of Princeton-Cordora-Glenn Irrigation District-Schaad Pumping Plant.

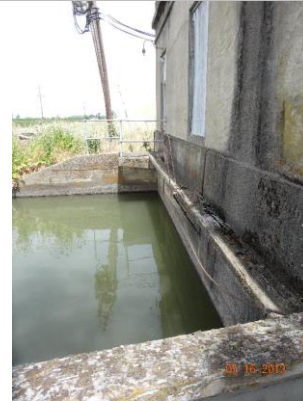
Photo 3 of 3 : UCIP_SP_2017_38167_69478.jpg

| FS_ID:38167 DS_ID:21171 EP_NO: N/A Repair Type: Non-Urgent Crossing Status: Found UCIP Comments: Three pipes found in the pump house on landward side. Pump house appears to be no longer in use. Unable to locate pipes on waterward side. Will need to contact owner to determine status. Owner will need to coordinate with CVFPB regarding proper removal per Title 23 requirements. FIELD_STRUCT_DESC: [Princeton-Cordora-Glenn Irrigation District: Schaad Pumping Plant] 3 of 3: 34-inch steel pipe sleeved through 36-inch steel pipe through the levee, 20.0 feet below the crown. Annular gap is grouted. Flap gate on landside (LS) end. Pump in pump house on LS slope. Rock revetment around outlet on waterside (WS) slope. (USACE-1955). This entry matches the Drainage or Irrigation Structure referenced in O&M manual (Station 41+47). Pipes sleeved through pre-existing pipes installed under Permit No. 2356 (1956). (Permit No. 2356-1956, Princetan-Codora-Glenn Irrigation District) FS Date: 5/16/2013 | | | | | | |

View of landward side--outlet.

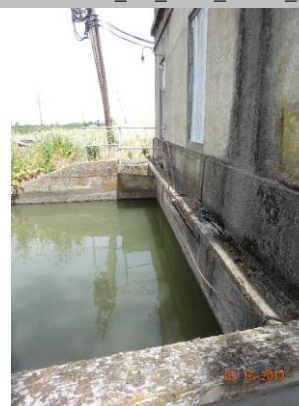
Photo 3 of 3 : UCIP_SP_2017_38168_69486.jpg

| FS_ID:38168 DS_ID:21182 EP_NO: N/A Repair Type: Non-Urgent Crossing Status: Indicator Found UCIP Comments: Unable to verify if the pipes inside the existings pump house correlate to 24-inch installed in 1955. Three pipes found in the pump house on landward side. Pump house appears to be no longer in use. Unable to locate pipes on waterward side. Will need to contact owner to determine status. FIELD_STRUCT_DESC: [Pumping Plant] 24-inch steel pipe through the levee, 27.3 feet below the crown. Flap gate on landside (LS). Pump in pump house on landside (LS). (USACE-1955). This entry matches the Drainage or Irrigation Structure referenced in O&M manual (Station 41+47). FS Date: 5/16/2013 | | | | | | |

View of landward side--outlet.

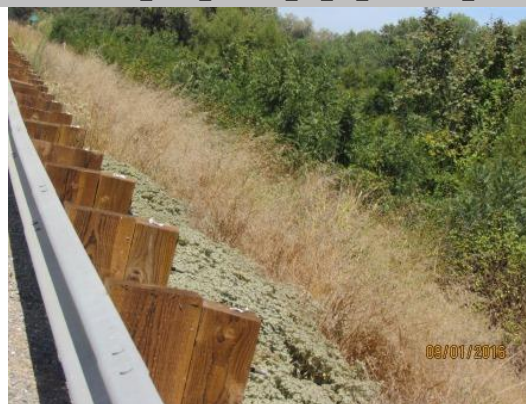
Photo 1 of 1 : SP_2017_LD0002_28_33_20170315_00016.jpg

View of the waterside vegetation looking upstream.

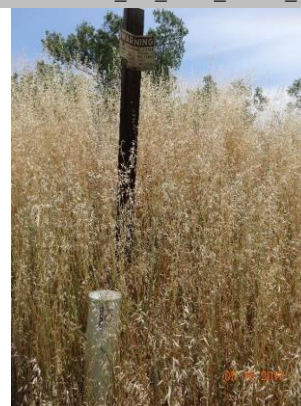
Photo 1 of 3 : UCIP_SP_2017_44170_72602.jpg

| FS_ID:44170 DS_ID:21177 EP_NO: 9723 Repair Type: Non-Urgent Crossing Status: Indicator Found UCIP Comments: Owner is listed as Pacific Bell however sign lists AT&T as owner, need to contact owner to determine if permit was updated or if this crossing is listed under new permit. Unable to confirm if 2 crossings are present at this site. FIELD_STRUCT_DESC: Buried telephone cable through the levee at unknown depth. Telephone pole and junction box on landside (LS) toe. This line was retained under an automatic board order (ABO) (Permit No. 9723-1974, Pacific Telephone Company). FS Date: 5/16/2013 | | | | | |

Indicators of existing line visible on slope.

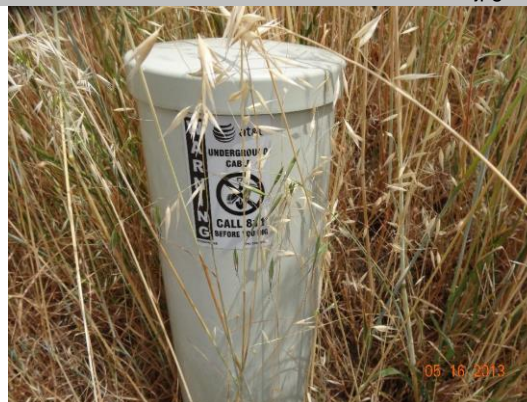
Photo 2 of 3 : UCIP_SP_2017_44170_72601.jpg

AT&T underground cable line.

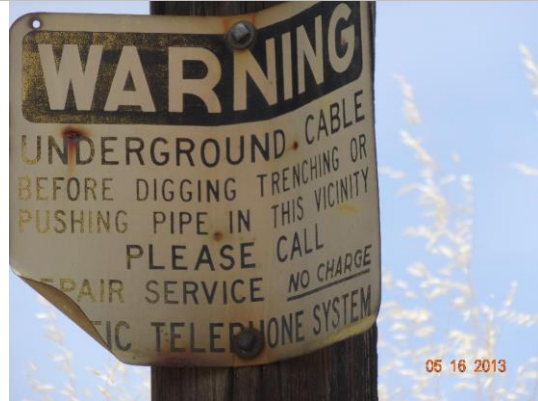
Photo 3 of 3 : UCIP_SP_2017_44170_72600.jpg

| FS_ID:44170 DS_ID:21177 EP_NO: 9723 Repair Type: Non-Urgent Crossing Status: Indicator Found UCIP Comments: Owner is listed as Pacific Bell however sign lists AT&T as owner, need to contact owner to determine if permit was updated or if this crossing is listed under new permit. Unable to confirm if 2 crossings are present at this site. FIELD_STRUCT_DESC: Buried telephone cable through the levee at unknown depth. Telephone pole and junction box on landside (LS) toe. This line was retained under an automatic board order (ABO) (Permit No. 9723-1974, Pacific Telephone Company). FS Date: 5/16/2013 | | | | | | |

Sign lists Pacific Telephone system.

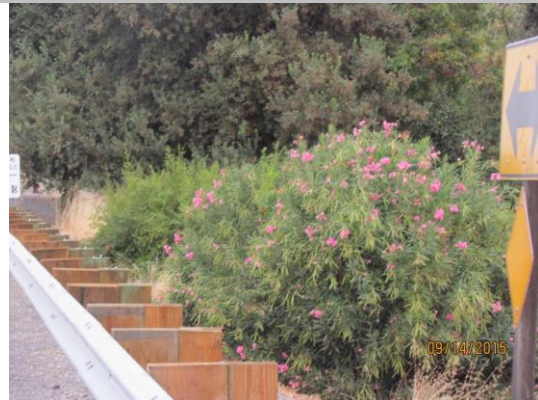
Photo 1 of 1 : SP_2017_LD0002_28_30_20170315_00014.jpg

View of the oleanders along the waterside slope.

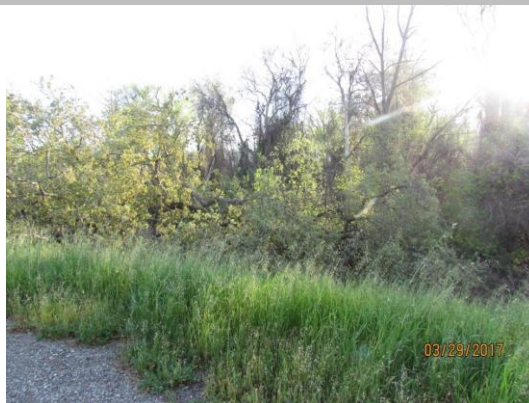
Photo 1 of 1 : SP_2017_LD0002_28_29_20170330_00054.jpg

View of the tree on the water side slope and toe.

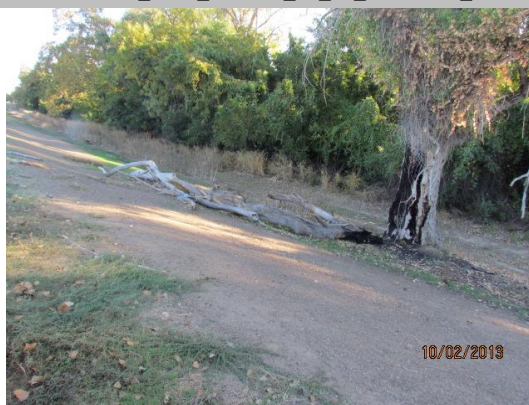
Photo 1 of 2 : SP_2017_LD0002_28_40_20170315_00019.jpg

View of the downed tree limb along the slope of the levee.

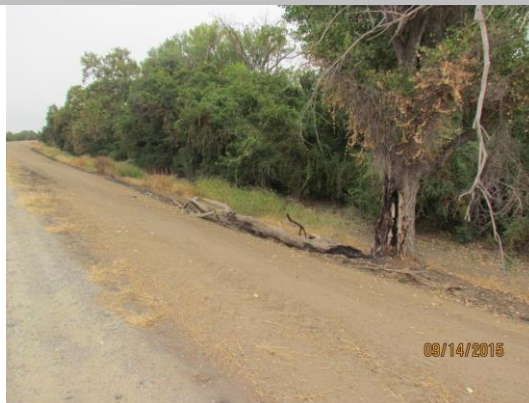
Photo 2 of 2 : SP_2017_LD0002_28_40_20170315_00020.jpg

View of the tree limbs along the waterside slope.

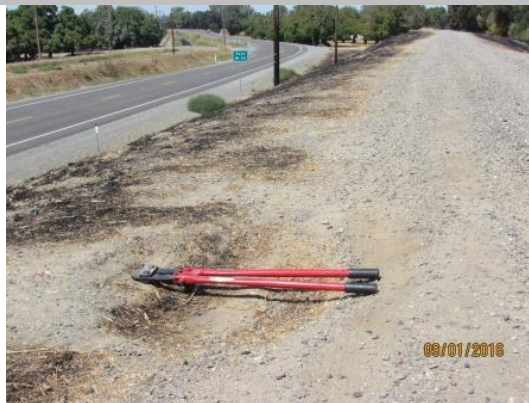
Photo 1 of 1 : SP_2017_LD0002_28_34_20170315_00017.jpg

View of a depression on the levee crown looking upstream.

| C2 : Repair depressions or ruts in the crown or slope. | | | | | |

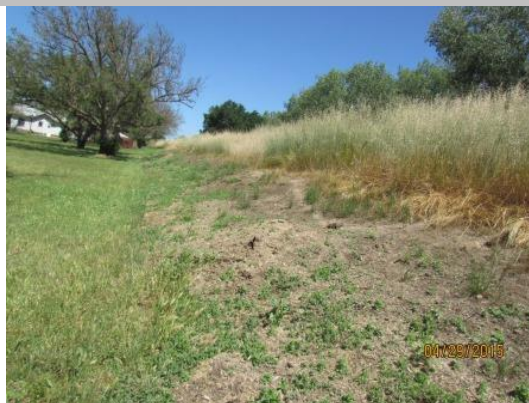
Photo 1 of 2 : SP_2017_LD0002_28_15_20170315_00008.jpg

View of the rodent holes along the landside slope.

| LMA needs to repair the rodent holes. | | | | | |

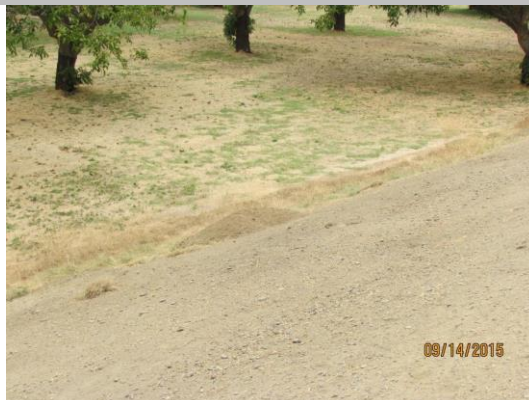
Photo 2 of 2 : SP_2017_LD0002_28_15_20170315_00009.jpg

View of the rodent holes along the landside slope.

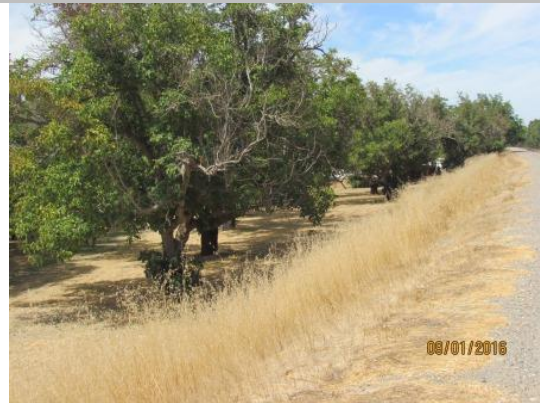
Photo 1 of 1 : SP_2017_LD0002_28_35_20170315_00018.jpg

View of the landside vegetation looking upstream.

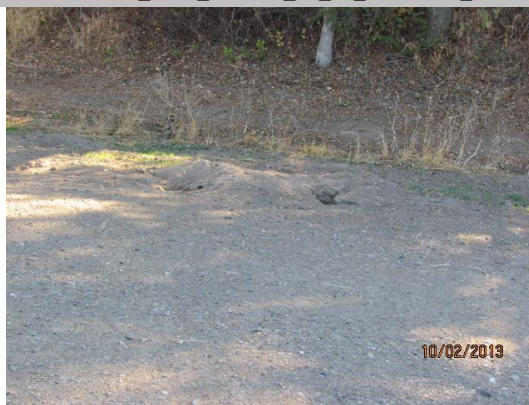
Photo 1 of 1 : SP_2017_LD0002_28_42_20170315_00021.jpg

View of the rodent holes along the slope of the levee.

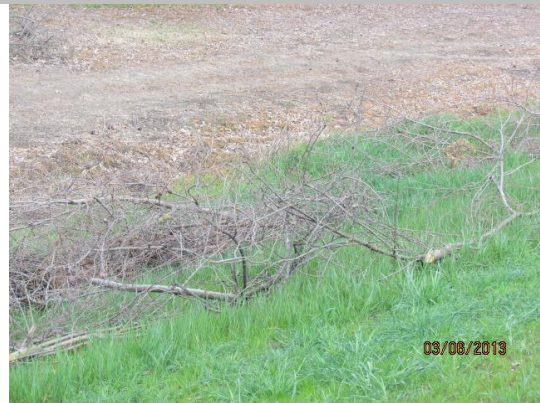
Photo 1 of 1 : SP_2017_LD0002_28_5_20170315_00002.jpg

View of the prunings along the landside toe.

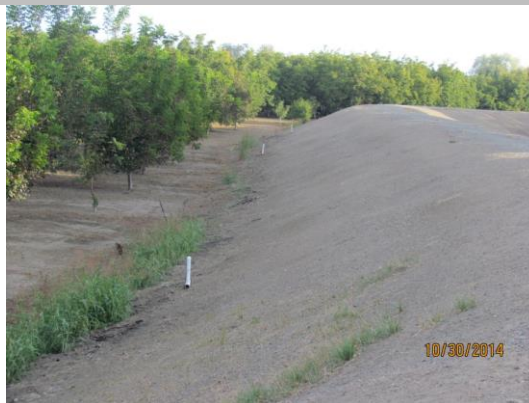
Photo 1 of 1 : SP_2017_LD0002_28_2_20170315_00001.jpg

View of the rodent holes and bait station along the landside slope.

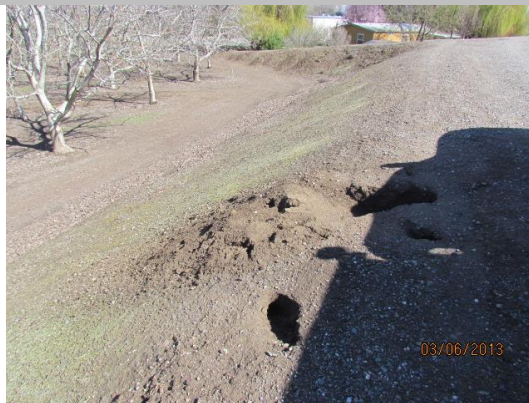
Photo 1 of 1 : SP_2017_LD0002_28_12_20170315_00006.jpg

View of the rodent activity along the landside slope.

| Repair the rodent holes along landside slope. | | | | | |

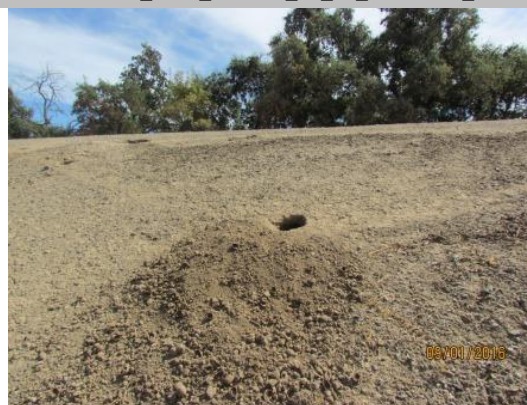
Photo 1 of 2 : SP_2017_LD0002_28_16_20170315_00010.jpg

View of the rodent holes along the landside slope.

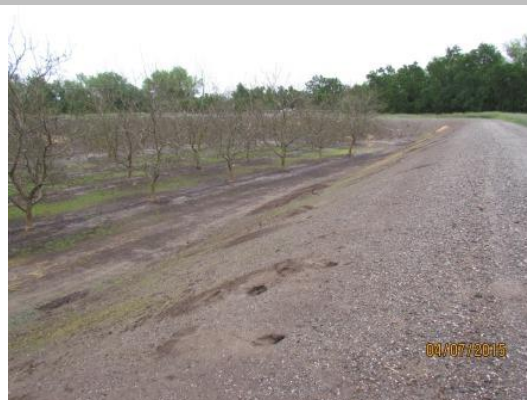
Photo 2 of 2 : SP_2017_LD0002_28_16_20170315_00011.jpg

View of the rodent holes along the landside slope.

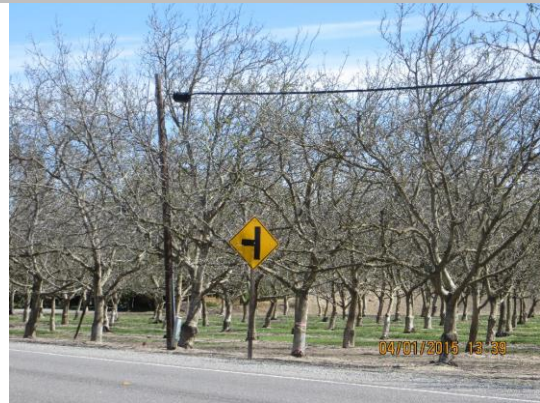
Photo 1 of 2 : UCIP_SP_2017_44186_73606.jpg

| FS_ID:44186 DS_ID:21188 EP_NO: 12444 Repair Type: Non-Urgent Crossing Status: Indicator Found UCIP Comments: Needs markers 10-feet off both levee toes. FIELD_STRUCT_DESC: Steel conduit through the levee, 2.5 feet below the crown. Conduit extends to pole on waterside (WS). Cut in pavement visible at levee crown (Permit No. 12444-1978) FS Date: 4/1/2015 | | | | | |

Conduit may be visible on pole about 1000-feet west of levee crown.

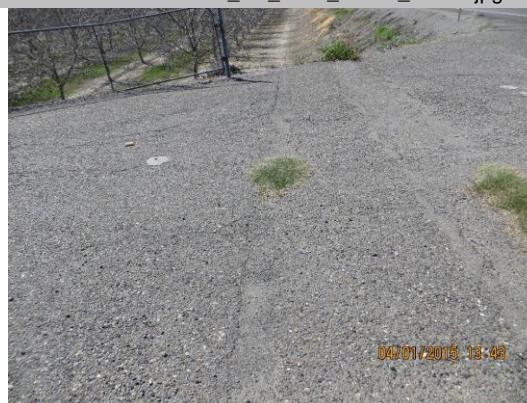
Photo 2 of 2 : UCIP_SP_2017_44186_73605.jpg

| FS_ID:44186 DS_ID:21188 EP_NO: 12444 Repair Type: Non-Urgent Crossing Status: Indicator Found UCIP Comments: Needs markers 10-feet off both levee toes. FIELD_STRUCT_DESC: Steel conduit through the levee, 2.5 feet below the crown. Conduit extends to pole on waterside (WS). Cut in pavement visible at levee crown (Permit No. 12444-1978) FS Date: 4/1/2015 | | | | | | |

Cut in pavement at levee crown good indicator of crossing.

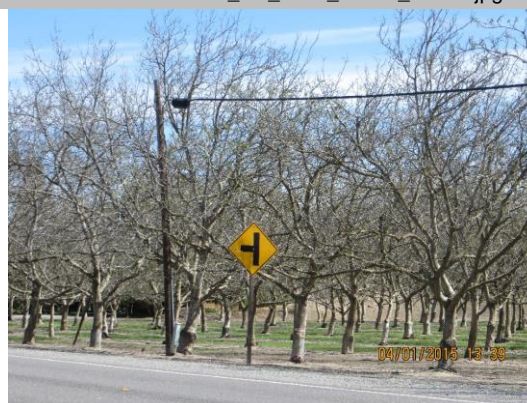
Photo 1 of 2 : UCIP_SP_2017_44185_73608.jpg

| FS_ID:44185 DS_ID:21175 EP_NO: 5376 Repair Type: Non-Urgent Crossing Status: Indicator Found UCIP Comments: Conduit needs markers ten feet off both levee toes. FIELD_STRUCT_DESC: Three 3.5-inch steel conduits through the levee, 3.0 feet below the crown. Metal cutoff wall around conduits near center of levee. Conduits are welded to the cutoff wall, extending only between the levee shoulders under the crown. Cut in pavement visible at crown. Cables extend to pole on waterside (WS). (Permit No. 5376-1967, Pacific Telephone & Telegraph Co.) FS Date: 4/1/2015 | | | | | |

Conduit may be visible at pole about 1000-feet west of crown.

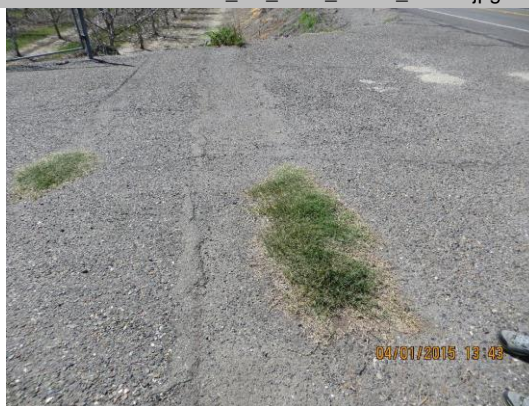
Photo 2 of 2 : UCIP_SP_2017_44185_73607.jpg

| FS_ID:44185 DS_ID:21175 EP_NO: 5376 Repair Type: Non-Urgent Crossing Status: Indicator Found UCIP Comments: Conduit needs markers ten feet off both levee toes. FIELD_STRUCT_DESC: Three 3.5-inch steel conduits through the levee, 3.0 feet below the crown. Metal cutoff wall around conduits near center of levee. Conduits are welded to the cutoff wall, extending only between the levee shoulders under the crown. Cut in pavement visible at crown. Cables extend to pole on waterside (WS). (Permit No. 5376-1967, Pacific Telephone & Telegraph Co.) FS Date: 4/1/2015 | | | | | | |

Cut in pavement visible at crown good indicator of crossing location.

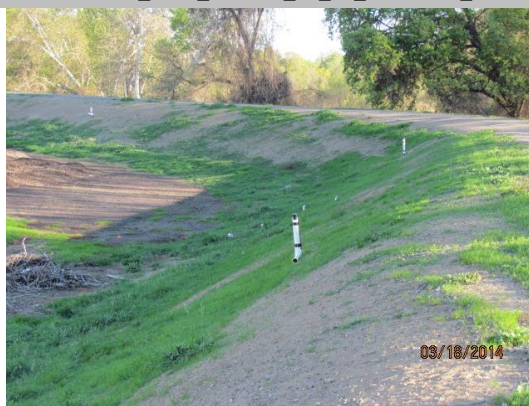
Photo 1 of 2 : SP_2017_LD0002_28_27_20170315_00012.jpg

View of the rodent activity along the landside slope.

| Repair the rodent holes on landside slope. | | | | | | |

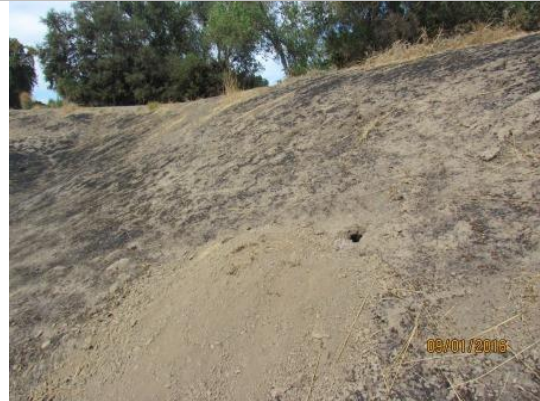
Photo 2 of 2 : SP_2017_LD0002_28_27_20170315_00013.jpg

View of the rodent holes along the landside slope.

| Repair the rodent holes on landside slope. | | | | | | |

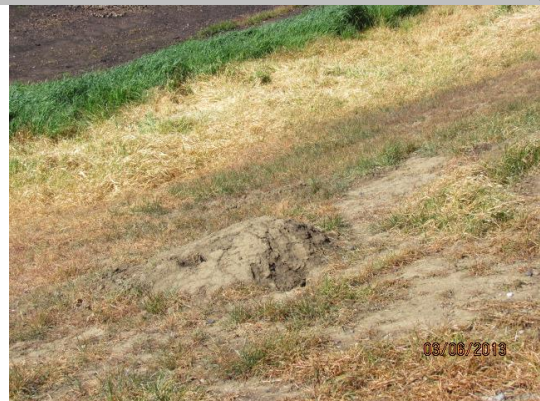
Photo 1 of 1 : SP_2017_LD0002_28_13_20170315_00007.jpg

View of the rodent activity along the landside slope.

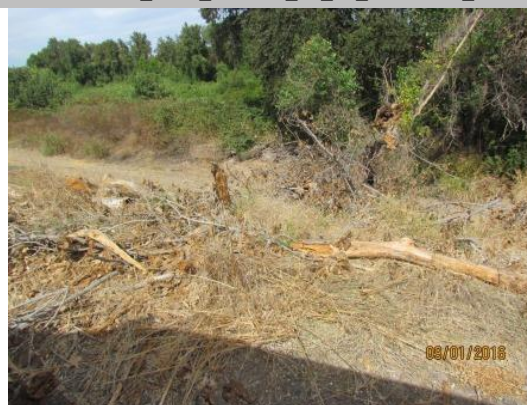
Photo 1 of 2 : SP_2017_LD0002_28_46_20170315_00022.jpg

View of a fallen tree along the waterside slope.

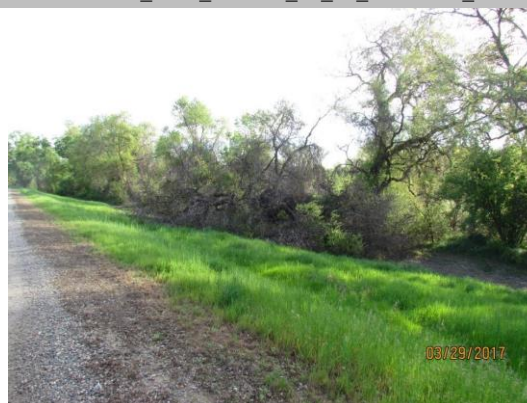
Photo 2 of 2 : SP_2017_LD0002_28_46_20170330_00055.jpg

View of the tree along the waterside slope and toe.

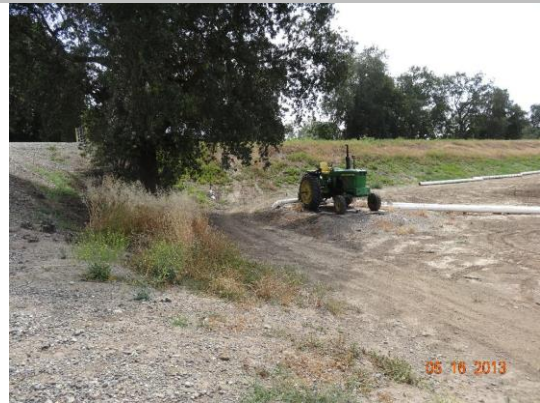
Photo 1 of 3 : UCIP_SP_2017_38178_69502.jpg

| FS_ID:38178 DS_ID:21178 EP_NO: 16931 Repair Type: Non-Urgent Crossing Status: Indicator Found UCIP Comments: Inspector notes indicate that pipe was never installed through levee and application was closed. Steel pipe was not installed but detachable section was installed. The pipe section goes up and over levee. Permit 16931 file was closed in 2005 owner was unable to install pipe due to costs. Permit indicates that pipe was to be used for winter supply of irrigation water to landward side. Need to coordinate with DWR inspector--permit revised for this type of structure. FIELD_STRUCT_DESC: Crossing visible at location. Current structure differs from original request in Permit No. 16931. PVC connection visible on landside (LS) toe with cutoff valve. Pipe connects to 8-inch PVC pipe extending past LS toe. FS Date: 5/16/2013 | | | | | |

View of pump system on landward side located behind tracker.

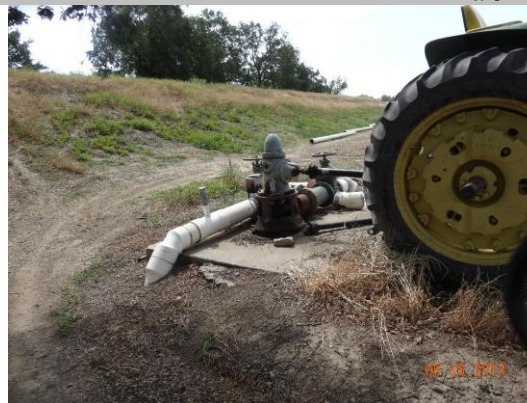
Photo 2 of 3 : UCIP_SP_2017_38178_69501.jpg

Pump system located near landward toe.

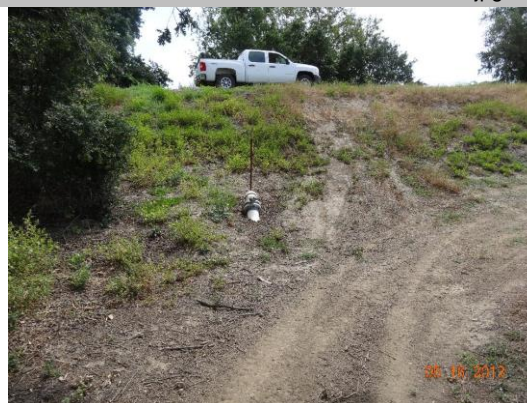
Photo 3 of 3 : UCIP_SP_2017_38178_69500.jpg

Pipe connection capped with control valve located on landward toe.

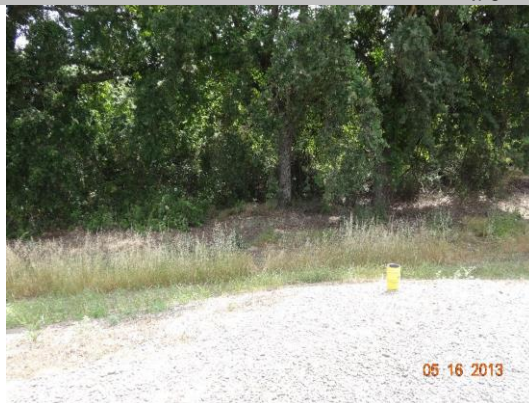
Photo 1 of 3 : UCIP_SP_2017_38182_69537.jpg

| FS_ID:38182 DS_ID:24659 EP_NO: N/A Repair Type: Non-Urgent Crossing Status: Found UCIP Comments: Need to contact owner to determine status of crossing. FIELD_STRUCT_DESC: 24-inch steel drainage pipe through levee at 2-feet below the crown. Pipe is exposed on waterside (WS) with air vent on the WS levee shoulder. Open pump is approximately 550 feet on the landside (LS) of the levee toe and concrete distribution pipe. (Permit No. 16280-1995, Mathew J. Southam/McGowan) FS Date: 5/16/2013 | | | | | |

View of waterward side.

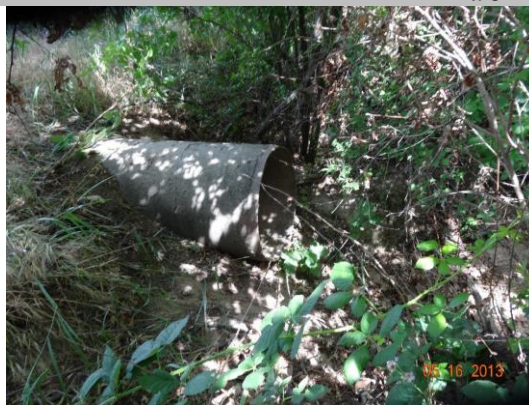
Photo 2 of 3 : UCIP_SP_2017_38182_69533.jpg

Pipe visible on waterward side.

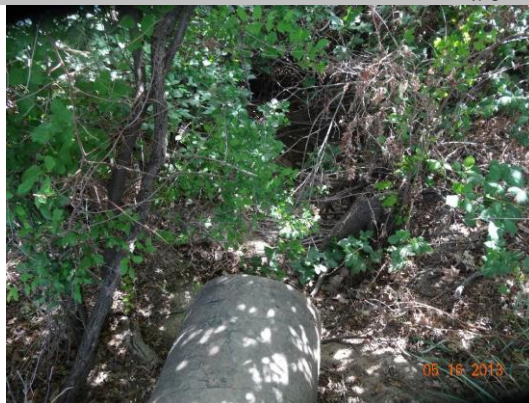
Photo 3 of 3 : UCIP_SP_2017_38182_69541.jpg

View of channel on waterward side.

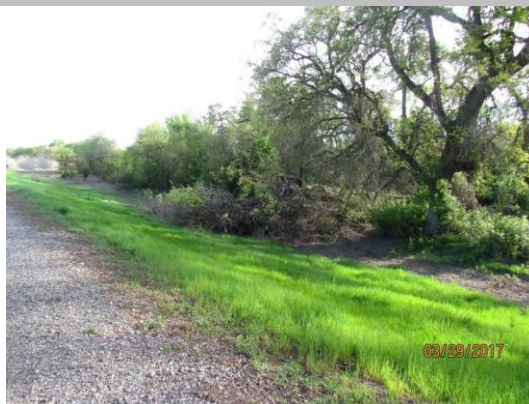
Photo 1 of 1 : SP_2017_LD0002_28_31_20170330_00056.jpg

View of the tree along the waterside slope and toe.

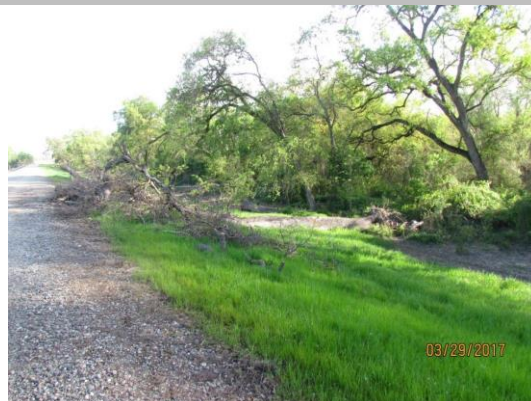
Photo 1 of 1 : SP_2017_LD0002_28_50_20170330_00057.jpg

View of the tree on the water sideslope and toe.

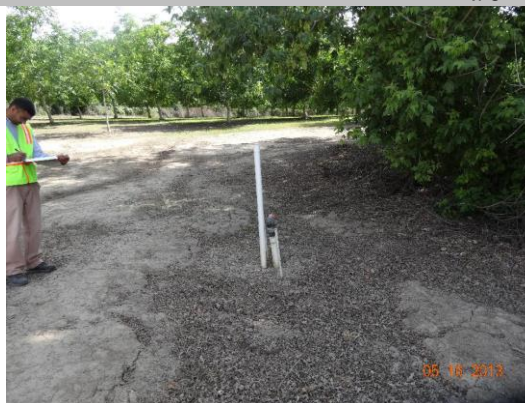
Photo 1 of 3 : UCIP_SP_2017_44188_69544.jpg

3-inch PVC pipe and vent exposed on waterward toe, likely in alignment with this crossing.

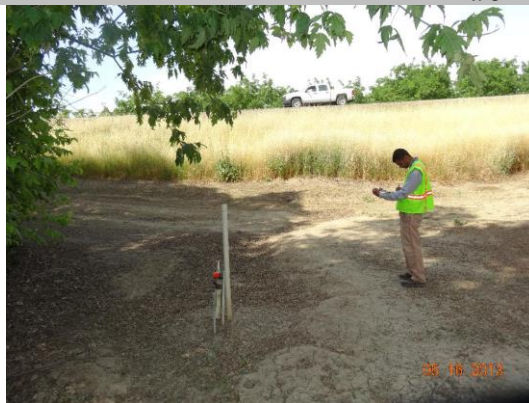
Photo 2 of 3 : UCIP_SP_2017_44188_69543.jpg

3-inch PVC pipe and vent exposed on waterward toe, likely in alignment with this crossing.

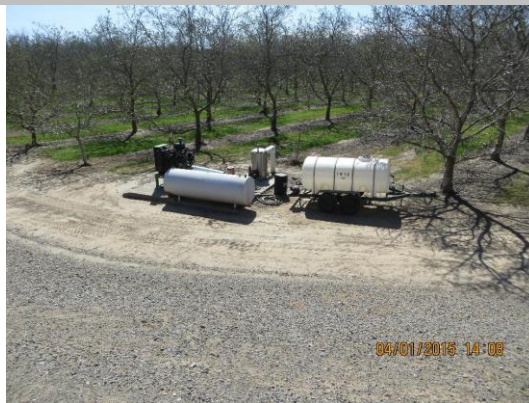
Photo 3 of 3 : UCIP_SP_2017_44188_73609.jpg

Well and pump visible on LS toe.

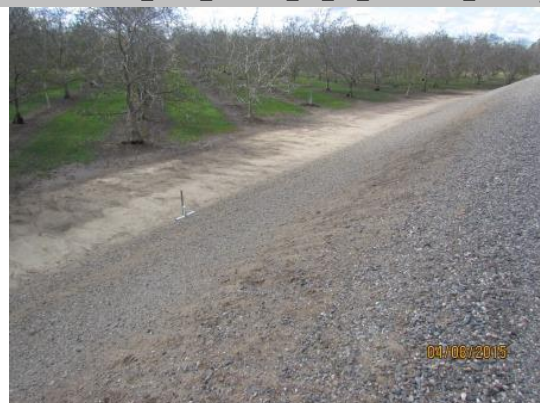
Photo 1 of 1 : SP_2017_LD0002_28_11_20170315_00005.jpg

View of the removed rodent holes and bait station.
